| PROCEDURE | | | |
|---|---|---|---|
| Reference: | PR20220901-01 | | |

| MODEL(S) | GOAL | |
|---|---|---|
| ALL EVOLUTION PLUS MODELS | Quality improvement | √ |
| PARTS INFO EV48-400 CONTROLLER | Down time | |

| TITLE |
|--|
| HOW TO FIX THE ALARM “ BUSBAR OVERVOLTAGE FAILURE” |

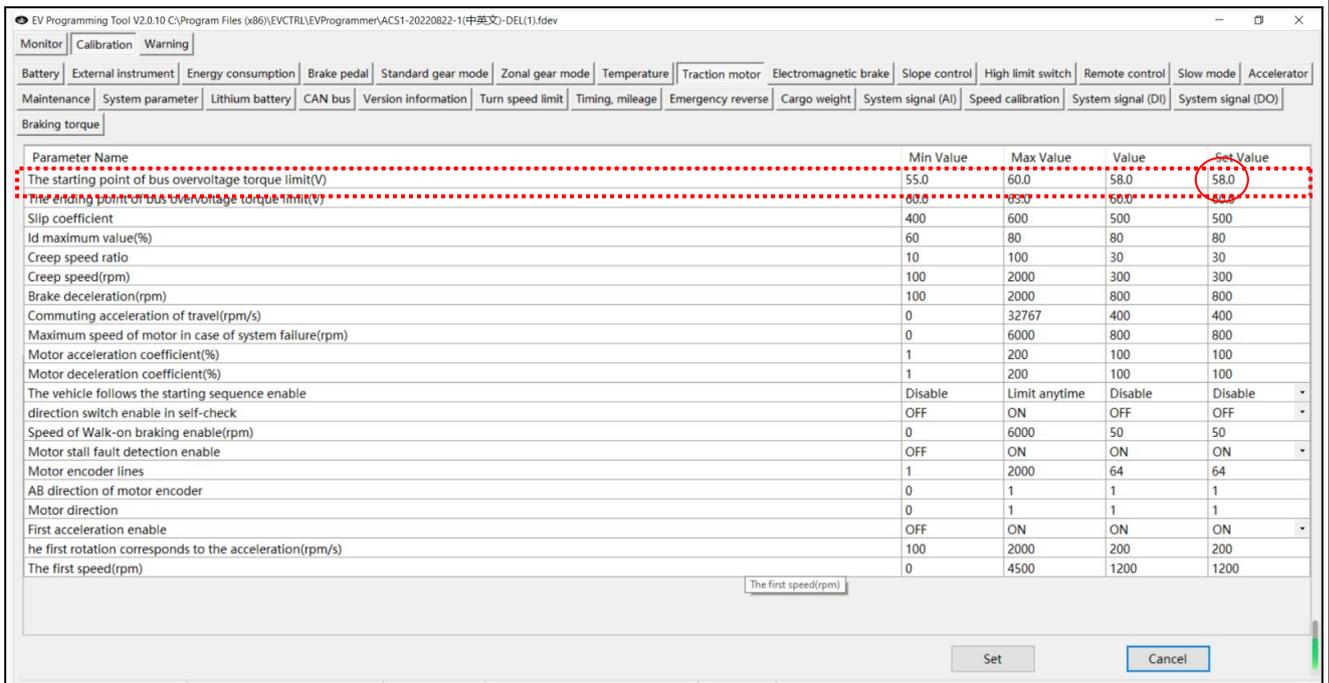
| DESCRIPTION /PURPOSE OF THIS PROCEDURE |
|---|
| The EVOLUTION controller always warns the “Bus overvoltage failure” or “Busbar overvoltage, brake output current red...” while driving. |

-Step 9. Enter into the “Calibration” menu, select “Traction motor”, adjust the “The starting point of bus overvoltage torque limit (V)” set value to “58”, click “set” button to activate the adjusting.
